STATE OF WASHINGTON DEPARTMENT OF NATURAL RESOURCES
WILDLAND FIRE INVESTIGATION REPORT

Case File Number
 23-E-LAB
 Other Related No.
 WA--SES--336

| Incident Name: Tunnel 5 | WildCAD Incident No. WA-SES-336 | Incident Date: 7/02 /2023 |

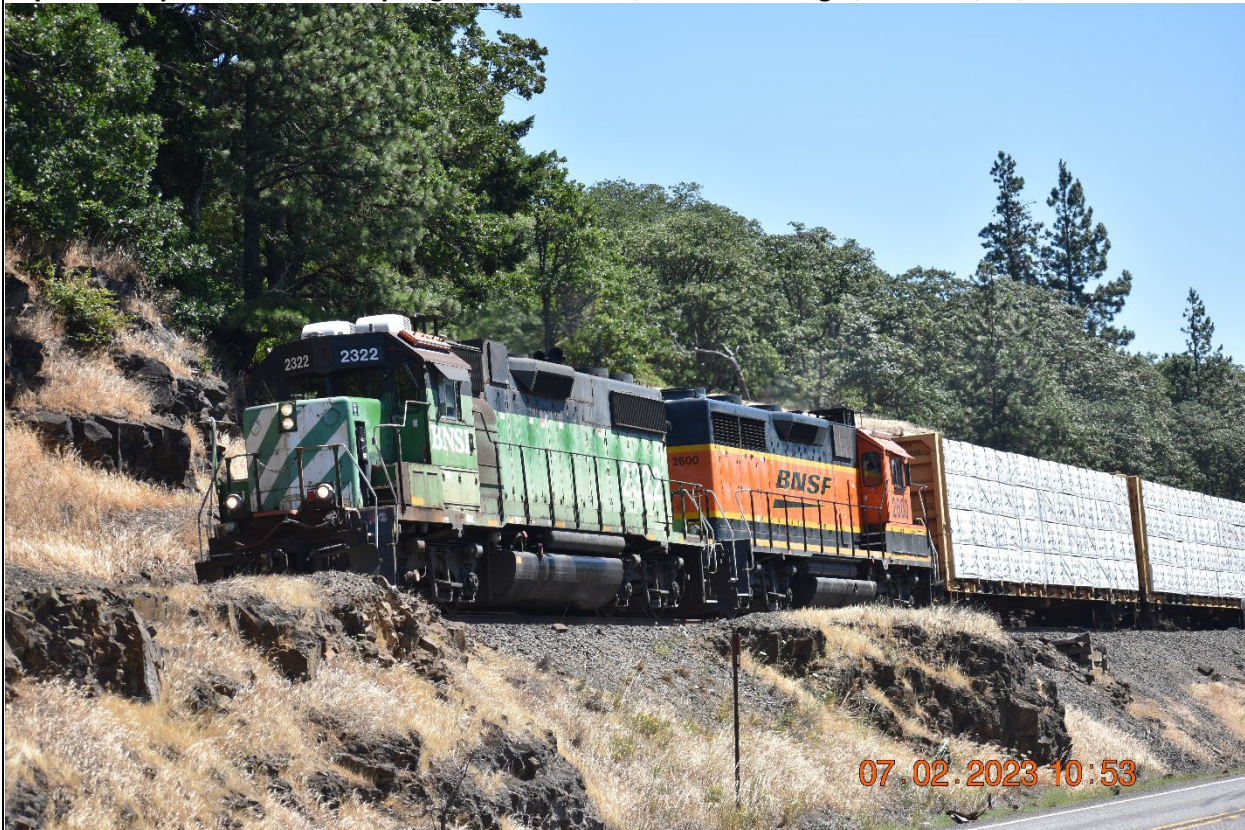
Bryan Baller photo of train at Spring Creek Rec Area, East of the origin, taken 07/02/23 at 1053 hours

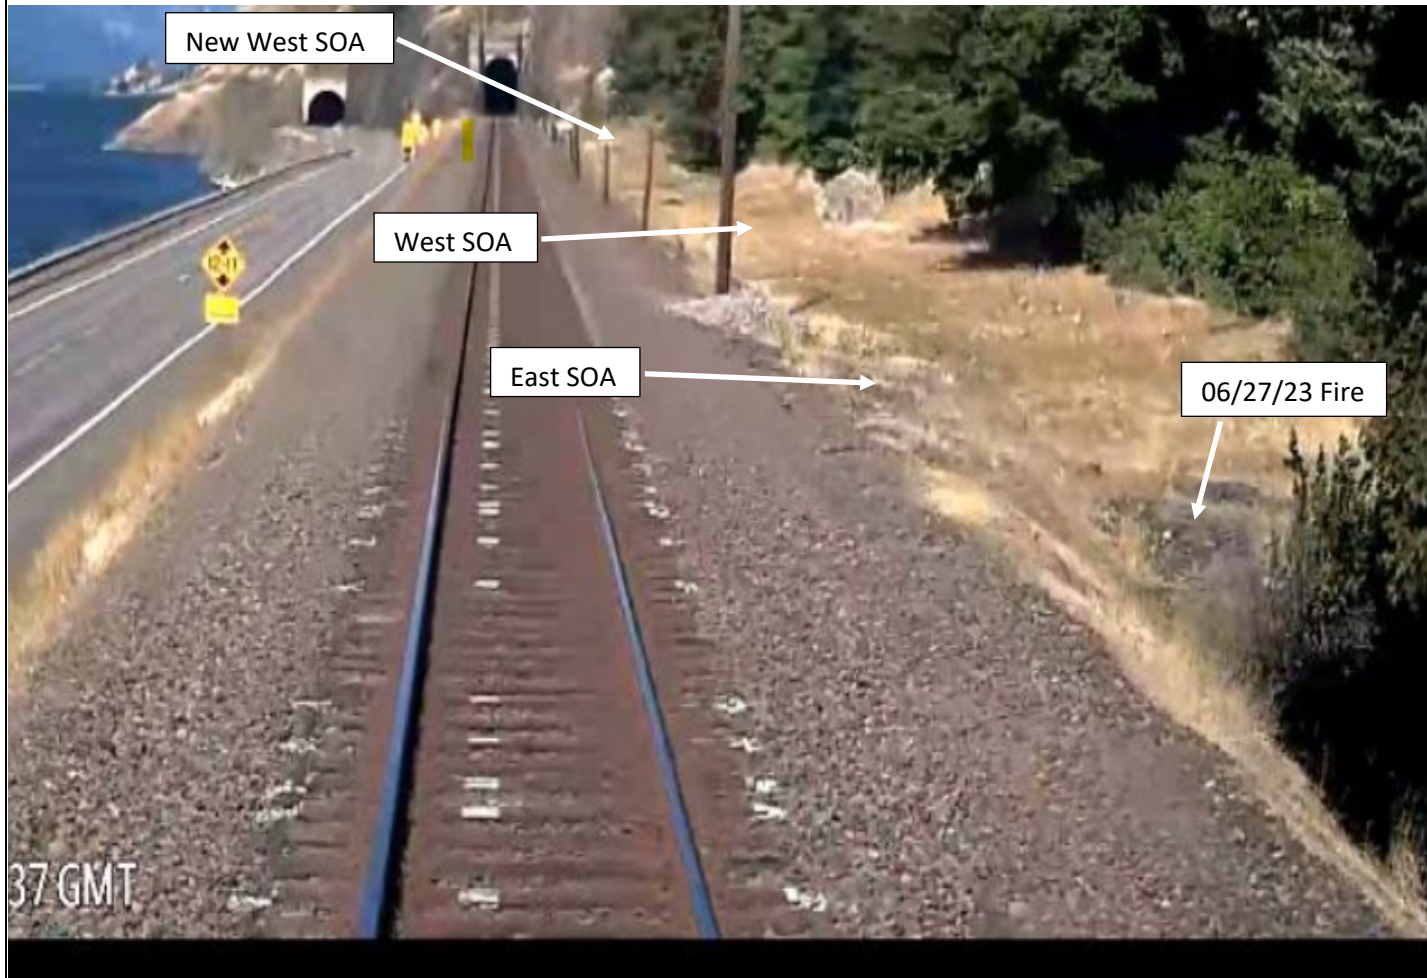
Amtrak Train Forward Camera

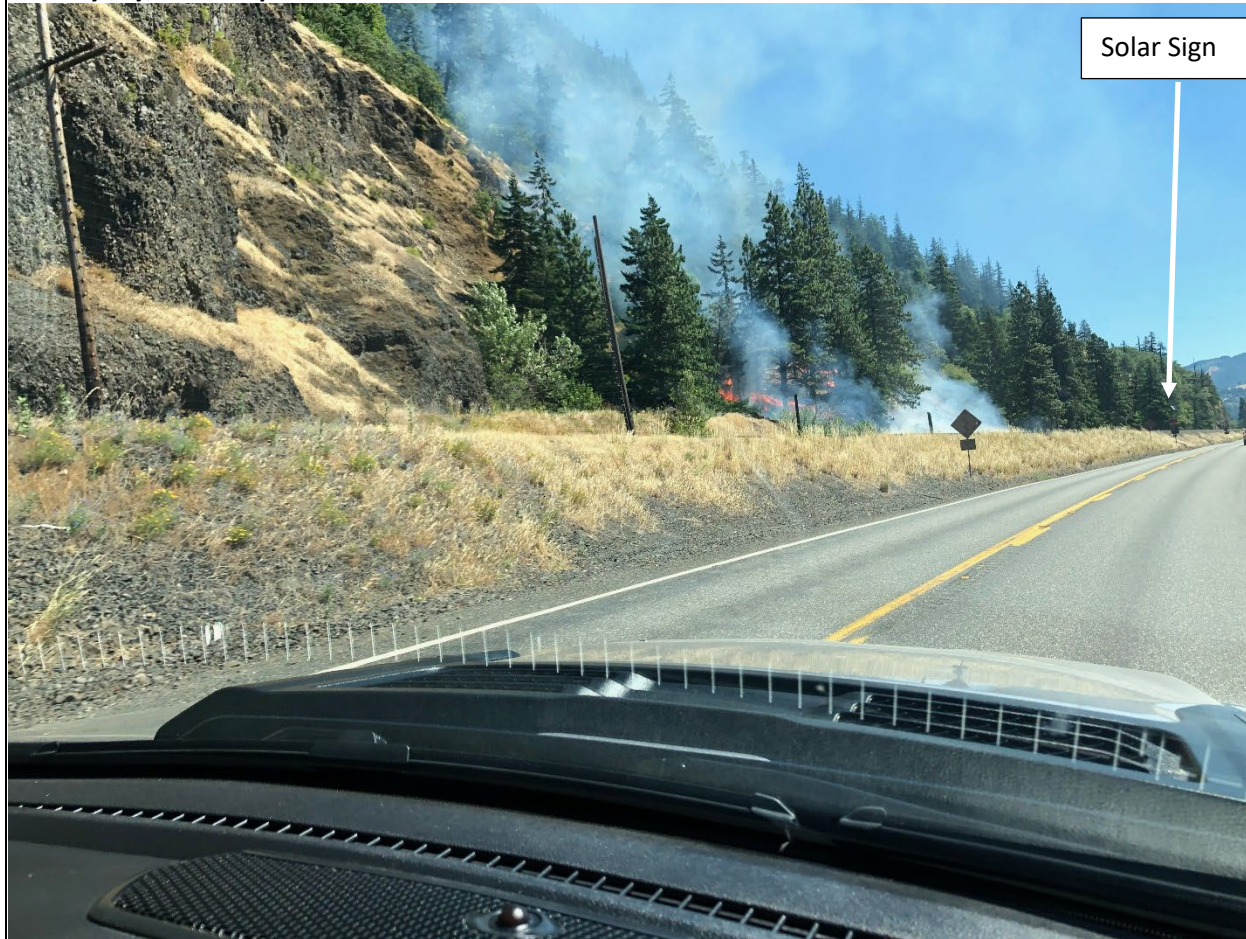
Mallory Fry, earliest photo taken at 1118 hours

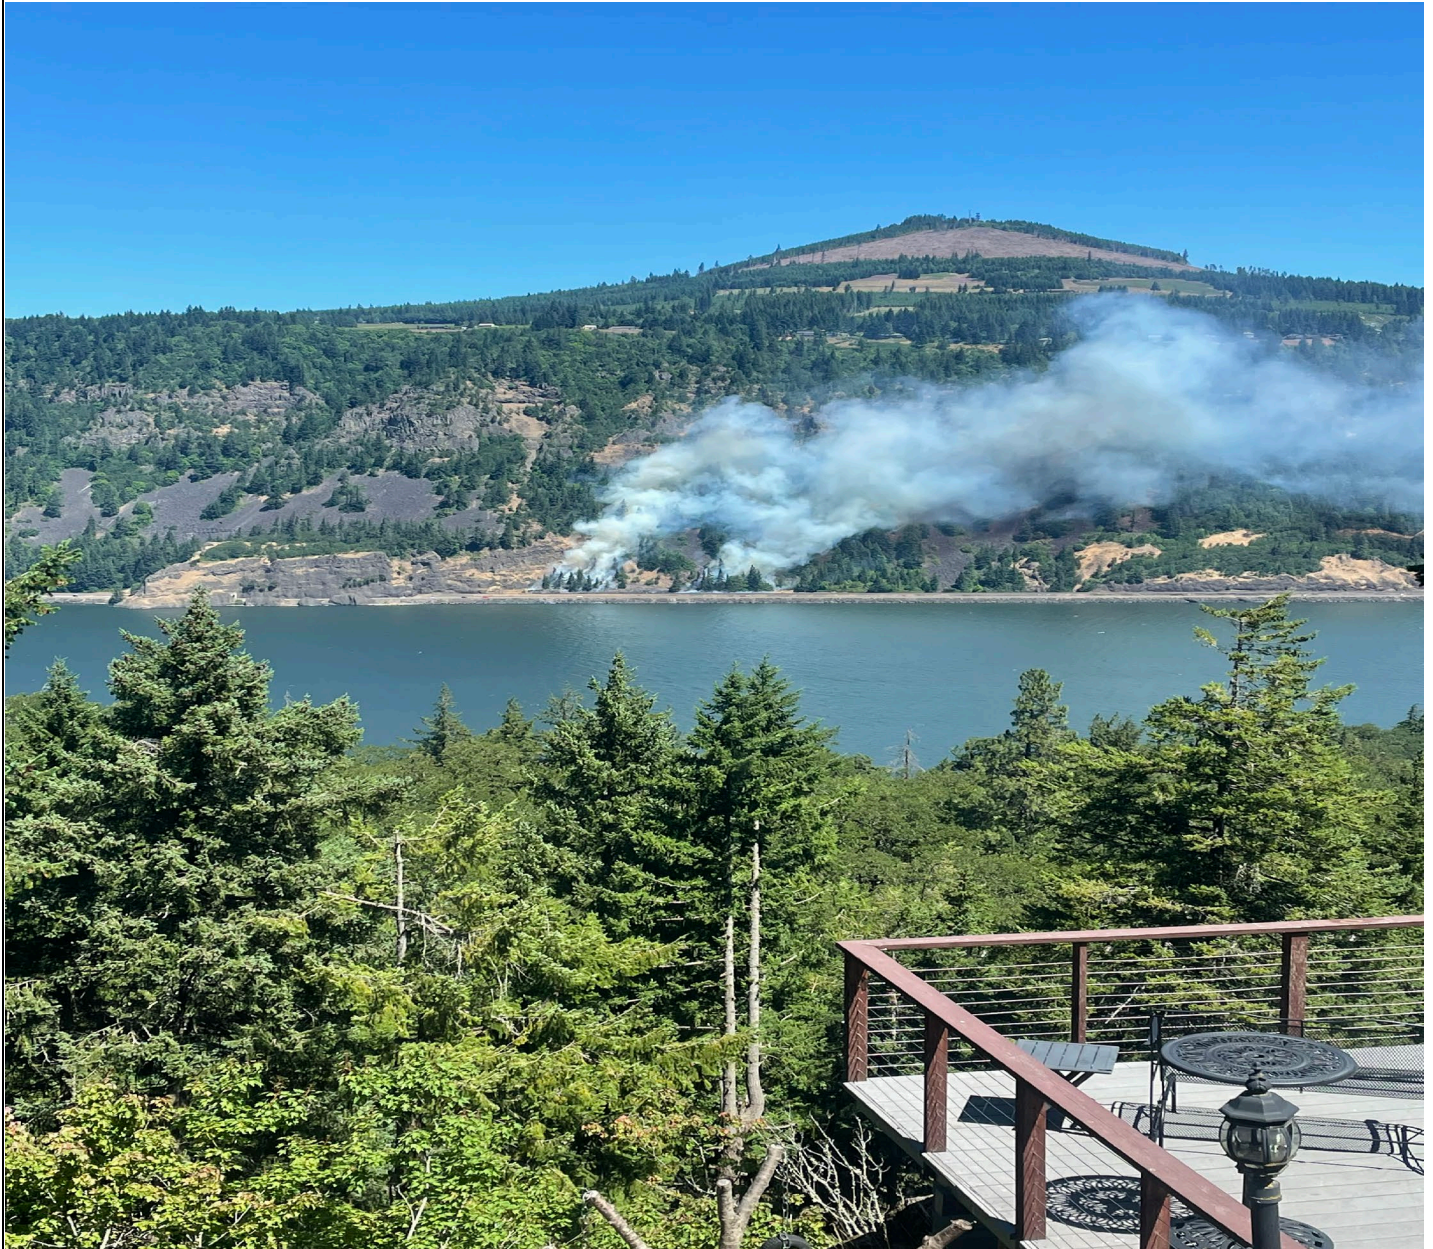
Debbi Trumbull first photo taken at 1126 hours on 07/02/23

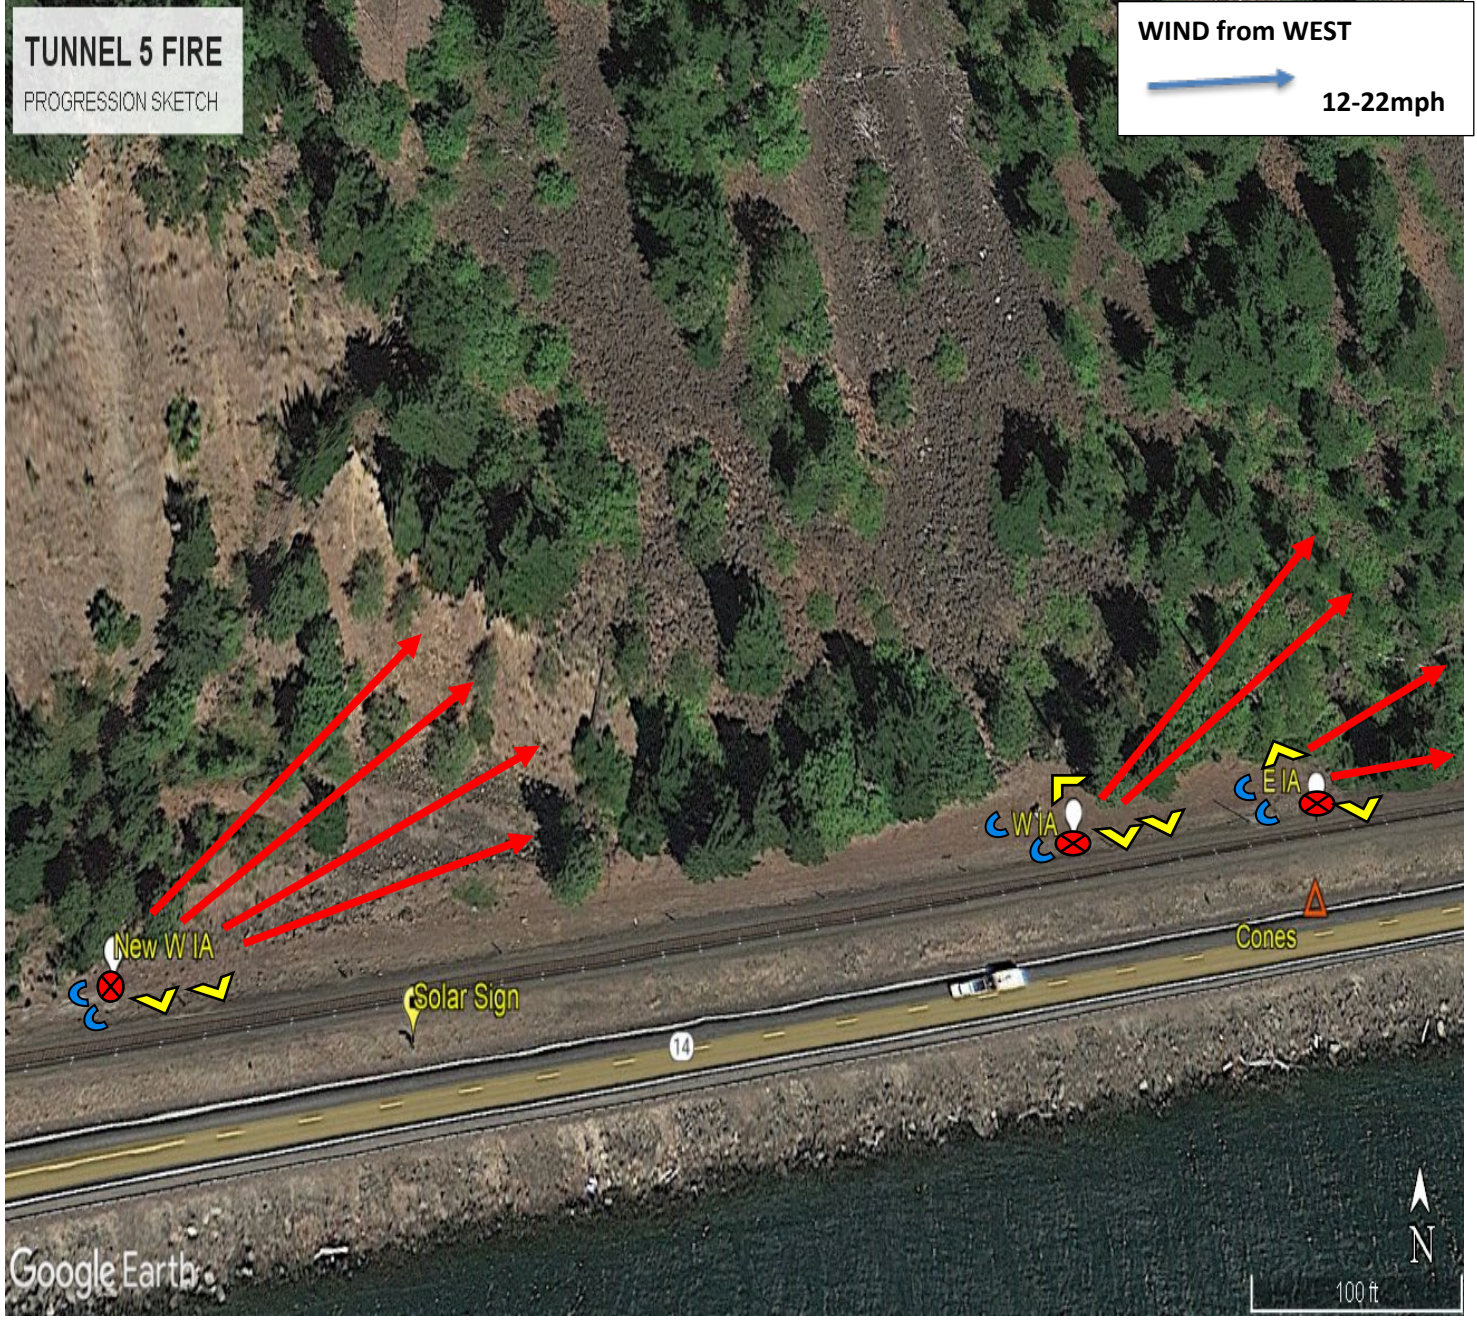
STATE OF WASHINGTON DEPARTMENT OF NATURAL RESOURCES
WILDLAND FIRE INVESTIGATION
ORIGIN AREA PROGRESSION SKETCH/DIAGRAM

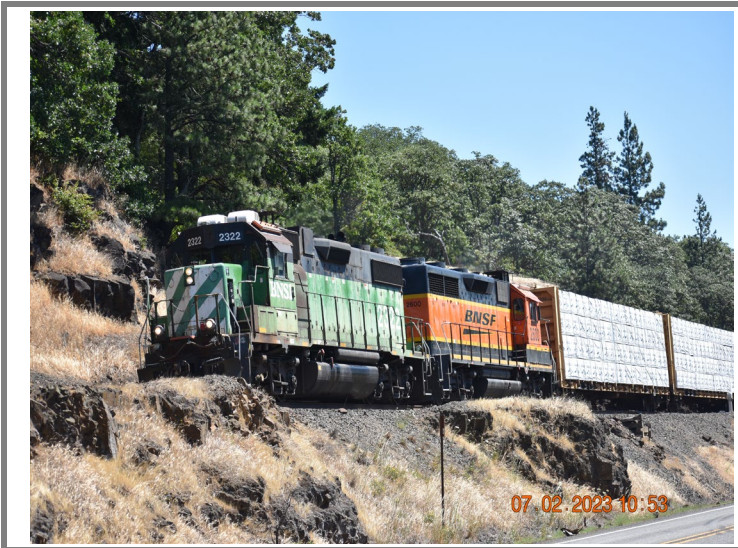
DSC_3437
 Looking NE; Bryan Baller pic of BNSF engines 2322 & 2600 WB toward the origins at 1053hrs, 17 min before fire.

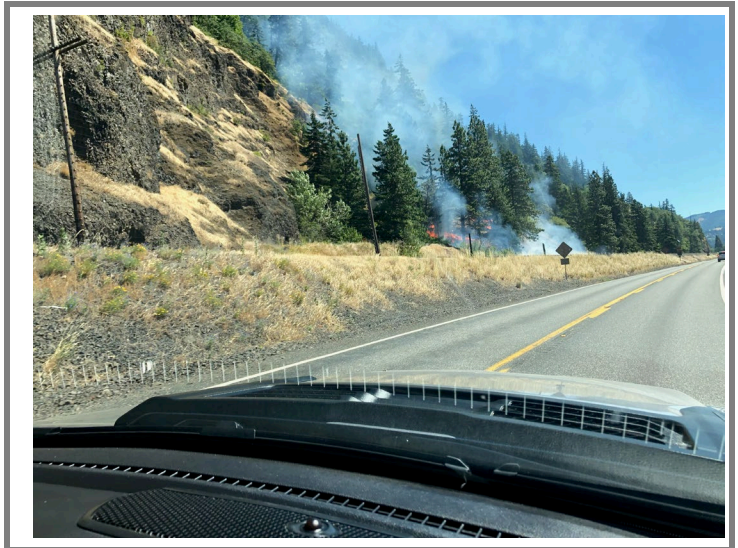
IMG_2250
 Looking E; Mallory Fry pic of fire at 1118hrs while driving WB.

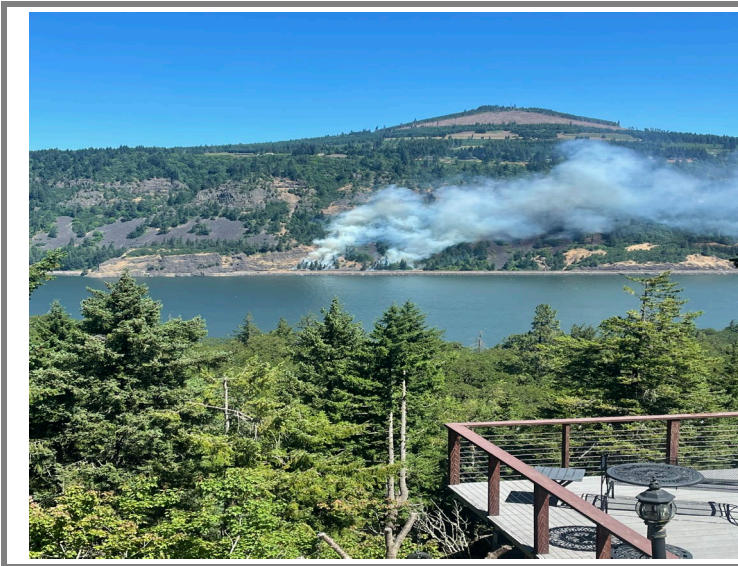
3
 Looking N; Debbie Trumbull pic at 1126hrs from OR side, shows 3 possible origin areas, furthest East is smallest.

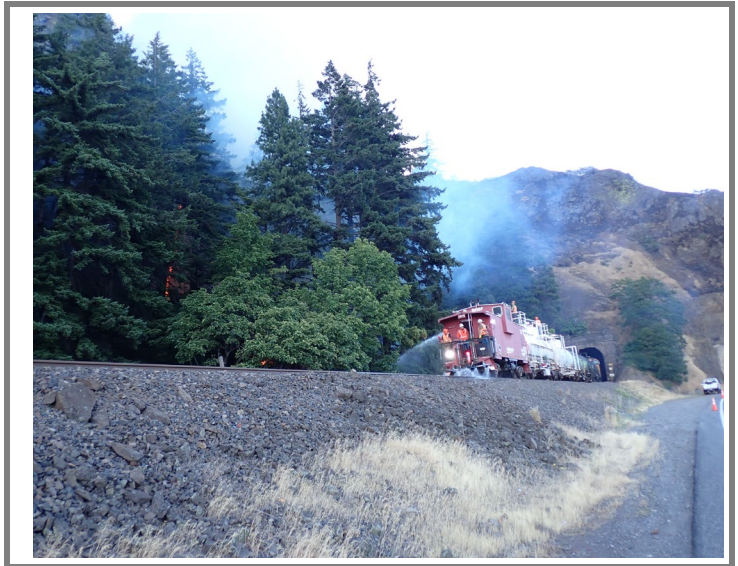
P7020001
 Looking NE; BNSF fire train, 1944hrs, w 4 - 16,000 gallon water tanks, EB in tunnel back toward origin on 2nd pass.

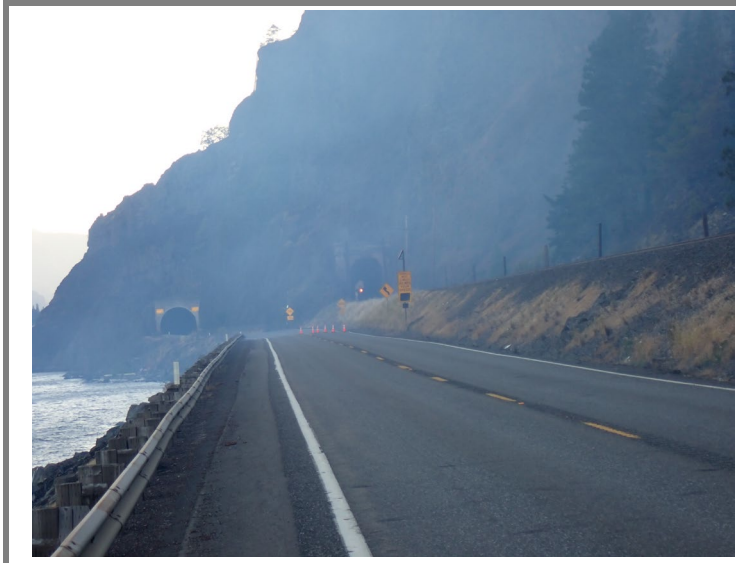
P7020005

Looking W; BNSF fire train EB in tunnel toward origins, on 2nd pass through with fire suppression water.

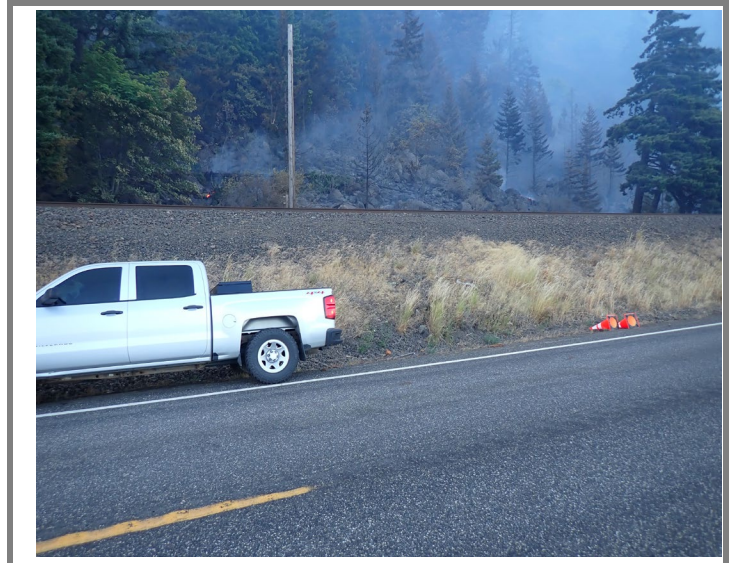
P7020007

Looking N; cones placed by first FFs, directing others to initial attack site near fire head just West of East origin.

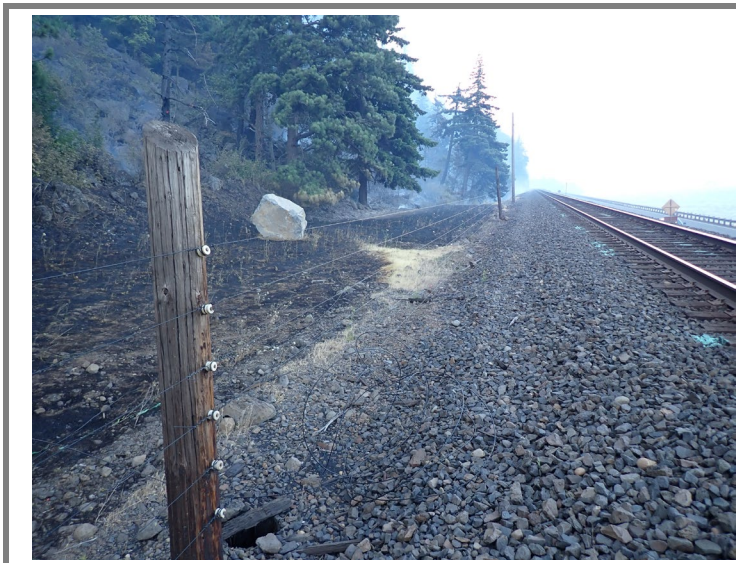
P7020020

Looking E; West origin just prior to fire train making 2nd pass with fire suppression water.

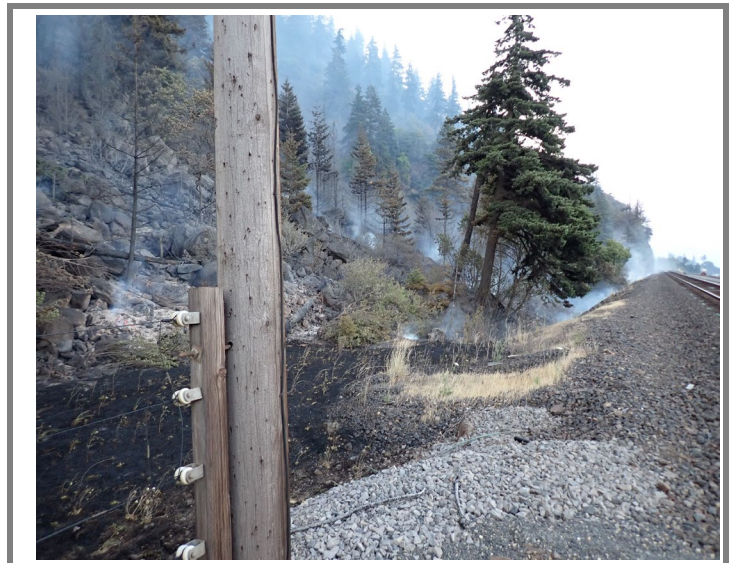
P7020030

Looking E; East origin just prior to fire train making 2nd pass with fire suppression water.

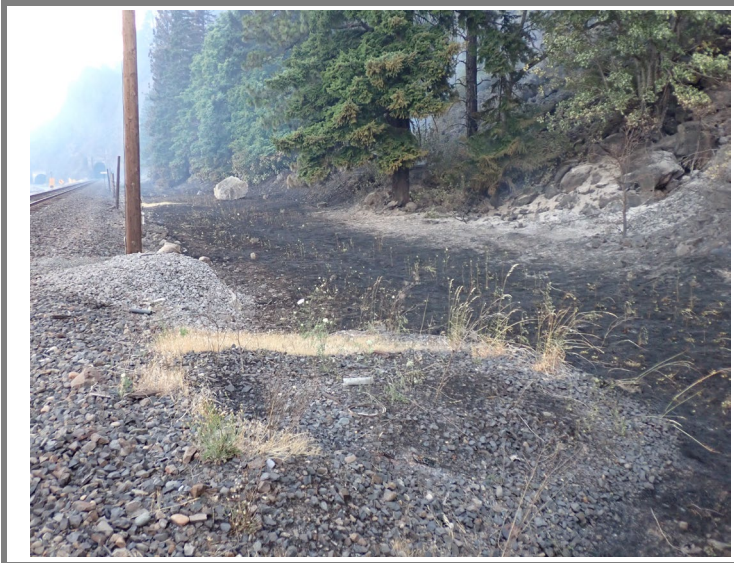
P7020032

Looking W; West & East origins in relation to each other, West origin is to the left of boulder.

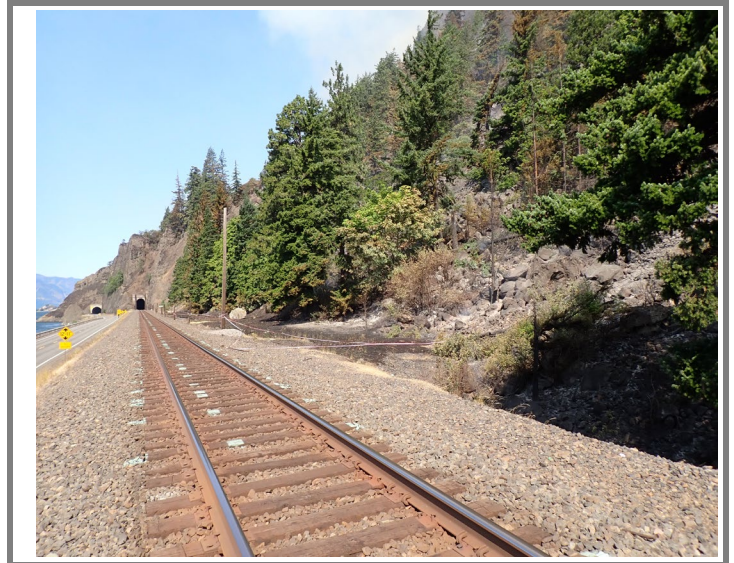
P7020039

Looking W; both West & East origins flagged off by me on the previous day, 07/02/23.

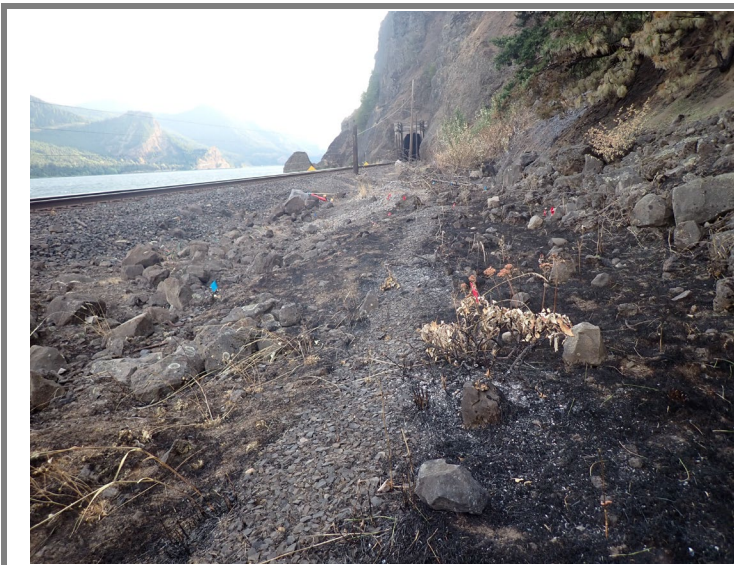
P7090009

Looking W; New West origin, West of solar sign, 07/09/23 after Trumbull interview. Fire backed W & advanced NE.

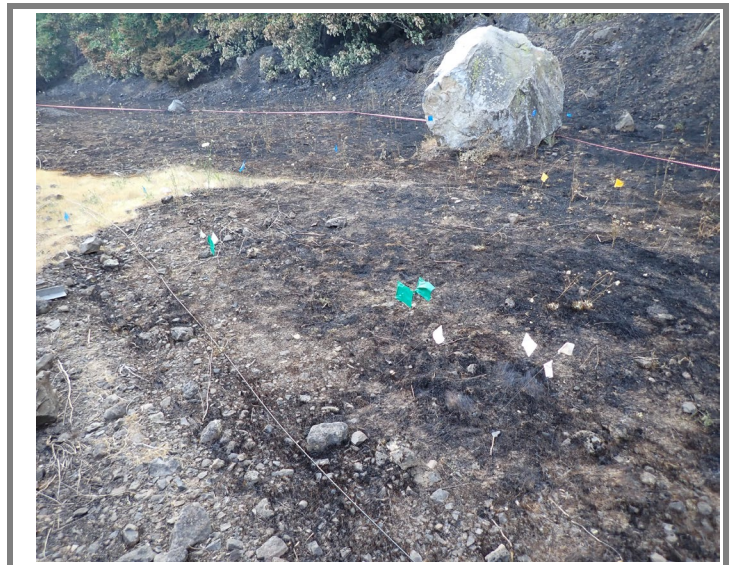
P7030076

Looking NW; original West origin with pin flags. Fire backed W & advanced NE.

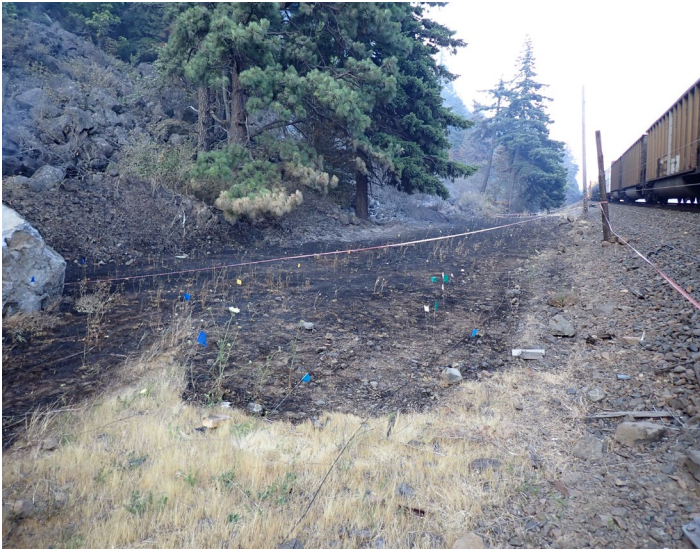
P7030077

Looking E; original West origin with pin flagging. Fire backed W & advanced NE.

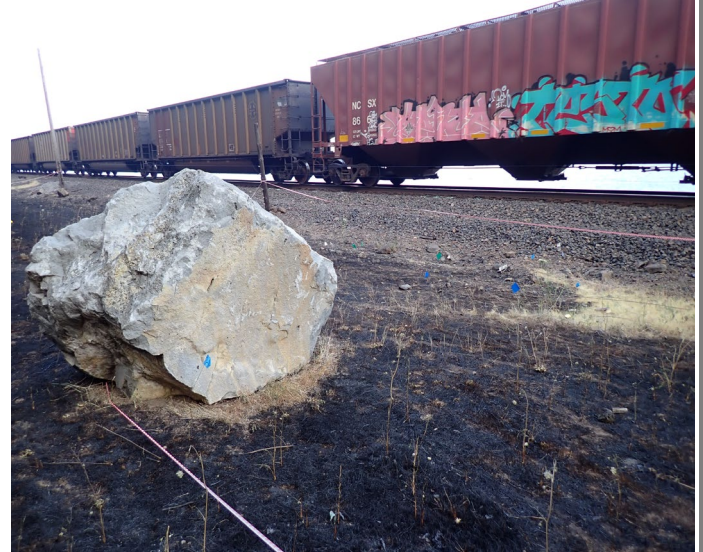
P7030078

Looking SE; original West origin with pin flagging. Fire backed W & advanced NE.

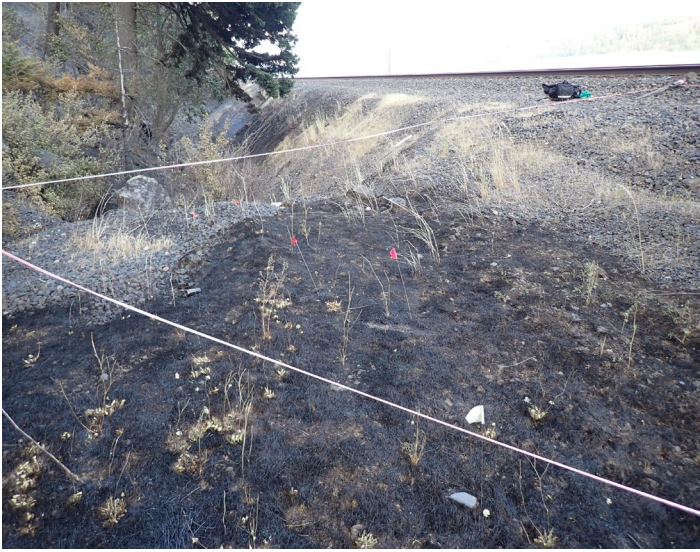
P7030071

Looking SE; East origin with pin flags. Fire backed W & advanced E.

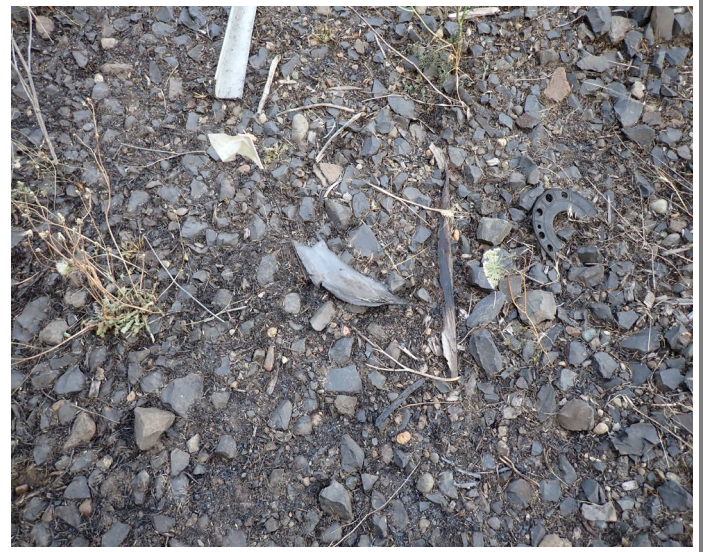
P7030091

Possible solid polymer train wheel lubricant pad parts in East origin.

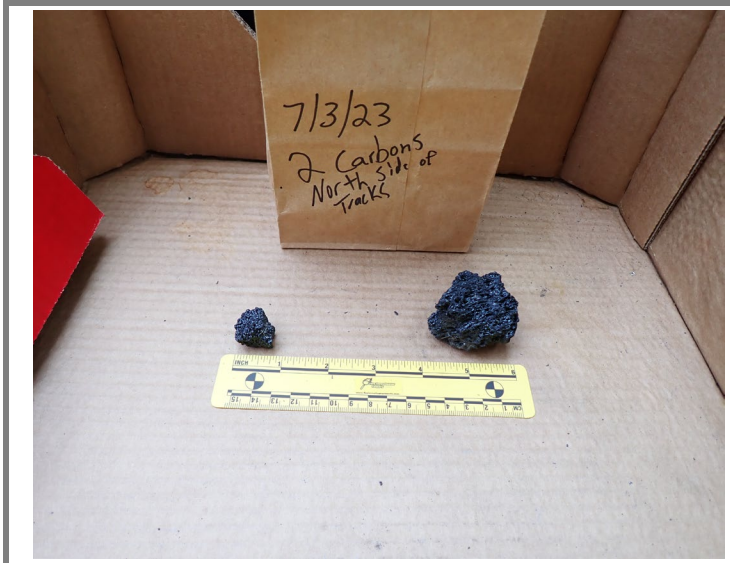
P7080004

2 possible carbon particles, 155" & 166" North of North side of tracks between original West & new West origins.

2 possible carbons North of the rail, at 155 inches North and 166 inches North of the North rail.

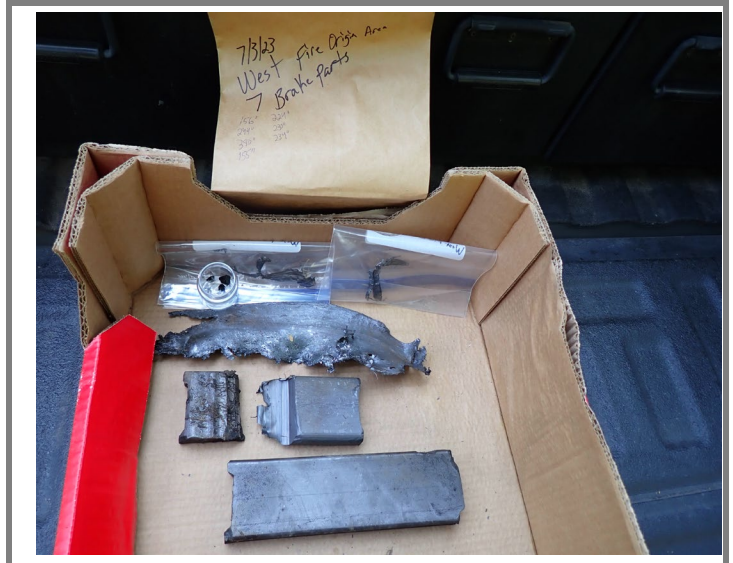
P7080006

7 possible solid polymer train wheel lubricant pad parts from West origin area, North side of tracks.

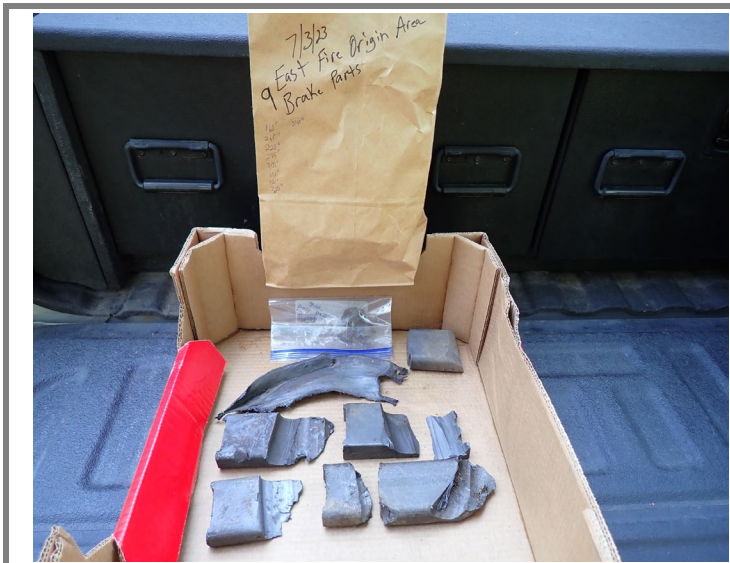
P7080005

9 possible solid polymer train wheel lubricant pad parts from East origin area, North side of tracks.

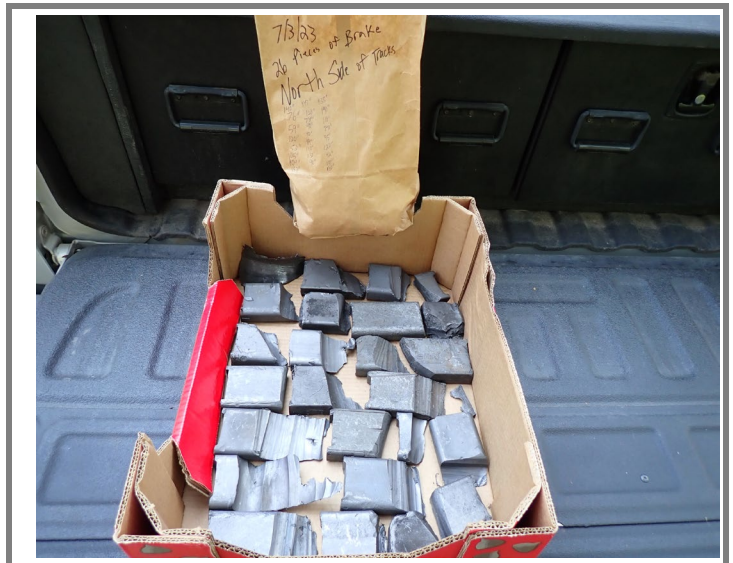
P7080002

26 polymer wheel lubricant pad parts from North side of tracks, outside of the origin areas. 72 pieces collected.
